# Surging the Upside-Down House: Looking into Upsetting Reference Voltages

Thomas S. Key  
Power Electronics Applications Center  
Knoxville TN

François D. Martzloff  
National Institute of Standards and Technology  
Gaithersburg MD  
f.martzloff@ieee.org

Paper presented at *PQA'94 Conference*, Amsterdam, October 1994

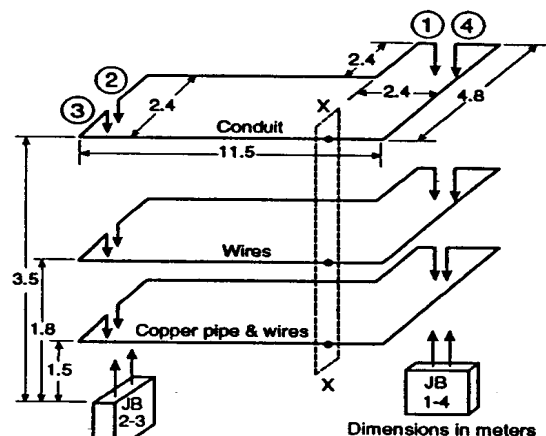
Figure 1 shows an isometric of the Upside-Down House configuration, with the arrangement of the three tiers of conductors shown in Figure 2. The power wiring includes two tiers of 3-conductor cable (2.05 mm dia. - #12 AWG, non-metallic jacket),

**Figure 1 - Schematic representation of the Upside-Down House conductors**

typical of residential wiring, and one tier of three 2.05-mm dia. conductors in a steel conduit, typical of commercial or office installation. A 4-conductor, two-pair telephone cable and a 70-Ω TV coaxial cable also run along the 3-conductor power cables.

To illustrate the expected benefit from good wiring practice (cables routed close to the earth reference -- the copper water pipe in the Upside-Down House), one tier has been lashed to the copper pipe. Of course, such idealized practice is not practical, but will serve here as baseline and illustration of EMC principles [Van Deursen, 1993]. In an actual installation, the system would exist in all three dimensions. For the sake of simplification, the Upside-Down House has been reduced to only two dimensions, one horizontal run spanning the house, and the vertical separation indicated in Figure 1. For the purpose of accessing both ends when injecting surges and measuring voltages and currents, the horizontal span has been folded into a hairpin with both ends accessible in junction box JB 1-4.

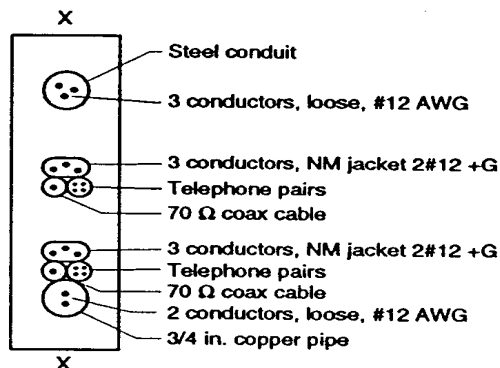
**Figure 2 - Vertical arrangement of conductors in the Upside-Down House (X-X of Figure 1)**

Junction box JB 2-3 provides access to an intermediate point of the span. Short cable runs (3 m), not shown on the diagram, provide for appliances located close to the service entrance.

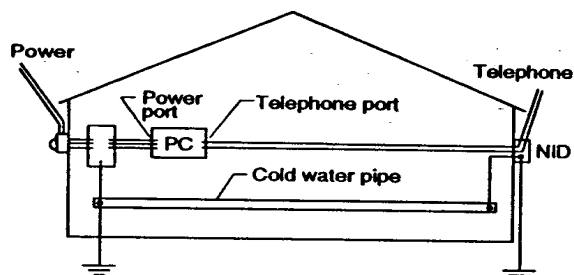
In this exposure scenario, a modem-equipped PC is connected by its power port to a branch circuit, and by its modem port to the telephone service of the house. For a worst-case scenario, the power and telephone services enter the house at opposite ends (Figure 3).

**Figure 3 - Power and telephone services entering the house at opposite ends, with PC connected across the two systems**

An open loop is formed by the copper pipe, the protective conductor (international symbol "PE") of the branch circuit feeding the PC, and the telephone wires from the NID to the PC. If a surge impinges on the external telephone plant, it is diverted by the NID via the copper pipe to the common earthing point of the house, at the power service entrance. The surge current in the copper pipe creates a changing magnetic flux around the pipe, which induces a voltage in the loop. This voltage will appear between the two PC ports if they are separated by a high impedance (of unknown surge voltage withstand capability).

With the telephone wires routed away from the copper pipe -- which can be expected in residential wiring -- a large loop is formed, embracing the flux produced by the surge current flowing in the copper pipe. With the telephone wires lashed to the copper pipe -- a theoretical more than practical routing -- the loop embraces less flux and one can expect a lower induced voltage across the two ports.

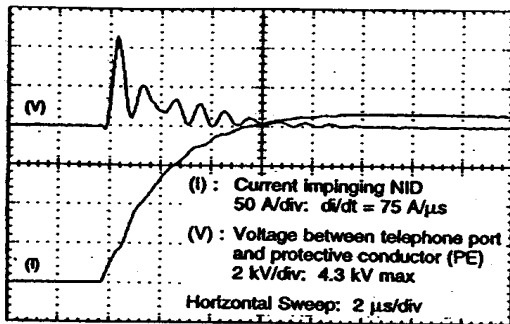
Figure 4 shows the recording obtained with the telephone wire routed away from the pipe. For a rate of change in the surge current of 75 A/ $\mu$ s, a peak of 4.3 kV is induced in the loop and appears between the two ports. For the same injection of current, a peak of only 1.3 kV was noted with the telephone wires lashed to the copper pipe.

**Figure 4 - Voltage difference recorded with telephone and power services entering at opposite ends of the house**

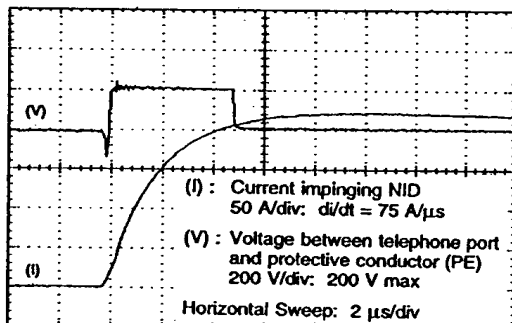
To illustrate the effectiveness, Figure 5 shows the reduction of the voltage obtained by inserting a typical surge reference equalizer in the power and telephone lines at the point of connection of the PC. The generic design of such a device includes insertion in the two telephone wires of two matched gas tubes, two series resistors, and two silicon avalanche diodes, with a shared earthing reference. Figure 5 shows the immediate clamping effect of the diodes down to 200 V, followed by a further reduction of voltage as the gas tube sparks over.

**Figure 5 - Mitigation obtained by inserting a surge reference equalizer in the power and telephone lines**

A relatively simple retrofit solution is to equalize the difference of voltage between the two systems by a device designed for the purpose and inserted in both communications and power links just before they enter the appliance. This device, defined in IEEE standards [IEEE Std 1100-1992] as a "Surge Reference Equalizer" is commercially available in the U.S. as a unit featuring a plug and receptacle for the power link, as well as a pair of telephone jacks or TV coaxial fittings for the communications link. However, its necessary effectiveness has not yet been quantified in any performance standard.

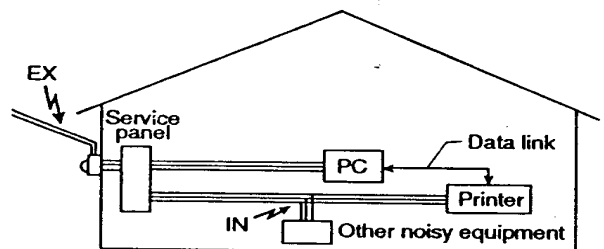
In this scenario, a PC and the associated printer are connected by the usual communications cable, and each is powered by a separate branch circuit. This situation is often encountered when a printer is shared among several users, or when an installation has been deliberately configured to provide a separation of the "clean" branch circuit supplying the PC from the "noisy" branch circuit supplying the printers and other peripherals (Figure 6). Both branch circuits originate at the service panel, but might not have the same length.

**Figure 6 - Personal computer and printer linked by a data cable and powered from two separate branch circuits**

In a first case of this scenario, a slight difference may occur in the time of arrival at the two ports of a surge originating outside of the building ("EX" in Figure 6). A greater difference in the time of arrival would occur if the surge were internally generated ("IN") along a branch circuit, propagating directly in that branch toward the PC and in a roundabout path via the service entrance and the other branch circuit toward the printer. With the internally generated surges having steeper fronts than the externally generated surges [Martzloff, 1990], the difference in arrival time would be significant since the voltage spike occurs upon the initial current rise, not at the peak of the current surge.

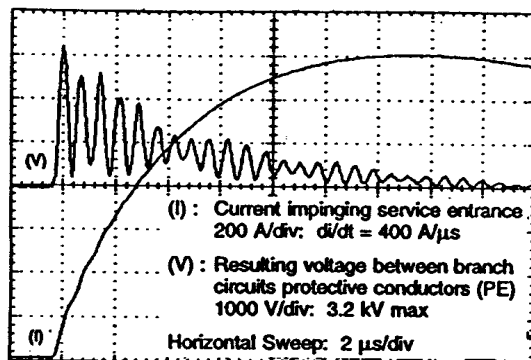
The effect of such difference in SPDs is illustrated in Figure 7, for the worst case scenario of one SPD connected L-G in one appliance, and none in the other. An oscillatory difference of voltage peaking at 3.2 kV, with a spike in the nanosecond range, occurs *at the time of the initial rise*, for the 400 A/ $\mu$ s rate of current change corresponding to an 8/20  $\mu$ s 1400 A peak surge injected at the service entrance. Note the decay of the voltage to a low value *at the time of the current peak*.

**Figure 7 - Difference of reference voltages caused by different protections in the two separate branch circuits**

As a second case of this scenario, a more severe situation is created by mismatched protective devices at the power ports of the two appliances. A shift in the reference voltage can occur if one SPD provided in either the printer or the PC invites a disproportionate surge current in its PE conductor. These can be built in the appliance or be a plug-in device installed by the user. Such a device, if it includes an SPD connected L-G, will return the surge to the service entrance through the protective conductor PE ("equipment grounding conductor" is the U.S. term) and produce a shift in the voltage of the corresponding chassis. The resulting difference of voltage between the two chassis will be applied across the communications link with possible upsetting or damaging consequences.
